## BALTIMORE CITY--COMMISSION FOR HISTORICAL AND ARCHITECTURAL PRESERVATION

SURVEY NO.: B-4236 MAGI NO.: 0442365404

ADDRESS: 109 North Poppleton Street

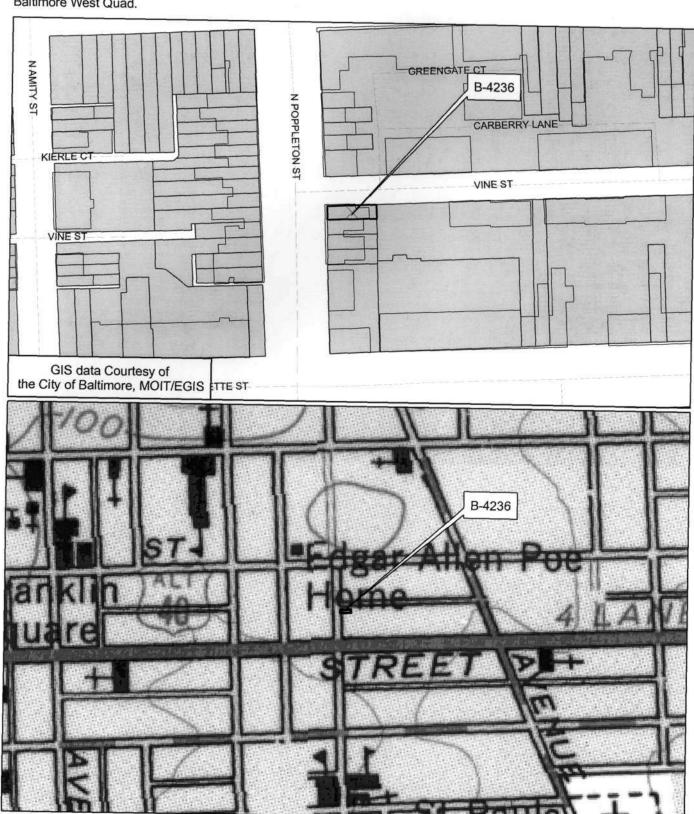
109 North Poppleton Street B-4236 Baltimore, Moryland Photographer: Janet Davis Dote: July 1988 Neg. loc.: Moryland SHPO Northwest Corner view

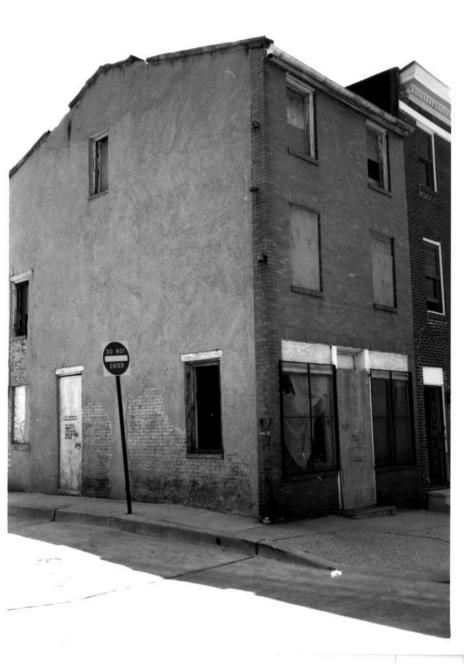
The three-story gable-roofed rowhouse is located on the southeast corner of North Poppleton and Vine Streets. The two-bay facade was probably rebuilt in the early to mid twentieth century in a stretcher bond with soldier course flat window and door arches and a storefront with flush display windows flanking a center door. Wood infill panels are located above each display window and a transom tops the doorway. The doorway itself is boarded and the display windows are covered by security screens. The upper story windows are boarded. The corbeled brick cornice is almost concealed behind a gutter. The side elevation is stuccoed with a boarded door and two window openings on the first floor, a single window toward the rear on the second floor, and a central window on the third floor. The gable end shows gaps where two interior chimneys have been removed down to the roof level.
